INTRODUCTION:

A BUILDER'S GUIDE TO OPEN-JOINT CLADDING SYSTEMS

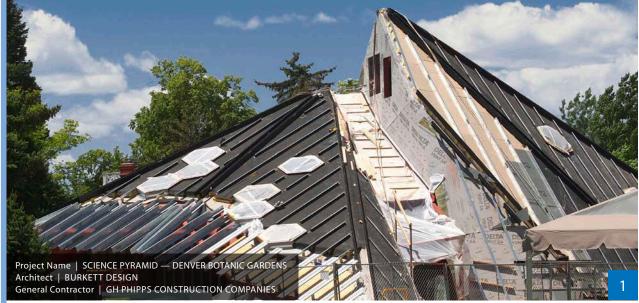
WRB behind open-joint cladding

This illustration shows that water-resistive barriers (WRBs) for open-joint cladding systems are installed in front of the continuous insulation (ci) and do not replace the primary air barrier/WRB, located in front of the structural sheathing.

Water-resistive barriers (WRB) specifically meant for open-joint cladding designs are intended to be installed in front of the continuous insulation (ci) and behind the cladding itself. At this location, it does not replace the primary air barrier/WRB—these membranes are located in front of the structural sheathing and behind the ci.

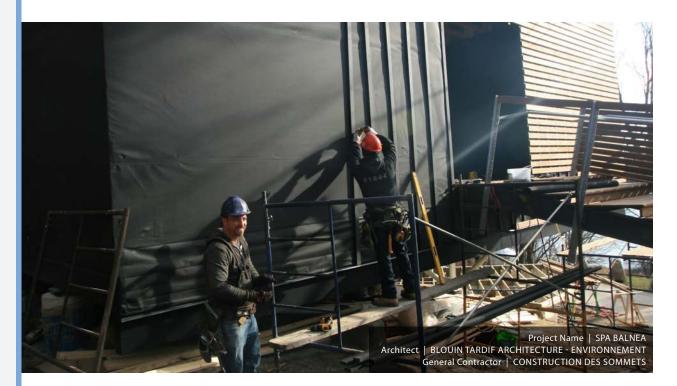
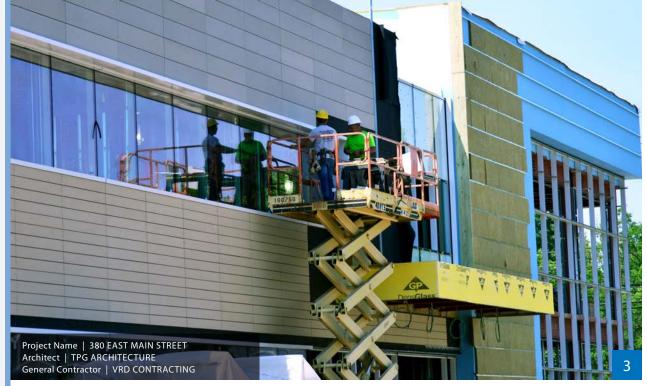
Along with being water-resistive, the right membrane should also be highly vapor permeable, allowing moisture within the cavity to escape swiftly through diffusion, while protecting the insulation from possible damage by moisture infiltration. Regardless of the type of membrane used, it is critical the moisture throttle should not be at this location to allow all interior moisture to diffuse freely to the exterior.

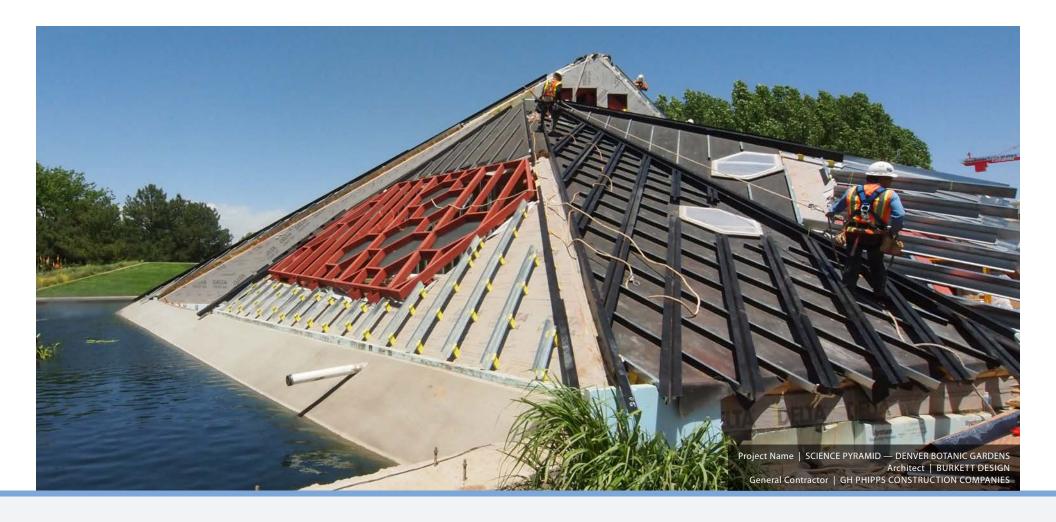
However, using a UV-stabilized membrane, along with best practices in understanding and preventing excessive UV exposure, will help to prevent negative impact on performance. DELTA®-FASSADE S is manufactured with a special acrylic coating to make it UV resistant. It may be used in systems with up to 50-mm (2-in.) openings comprising up to 40 percent of the overall façade.

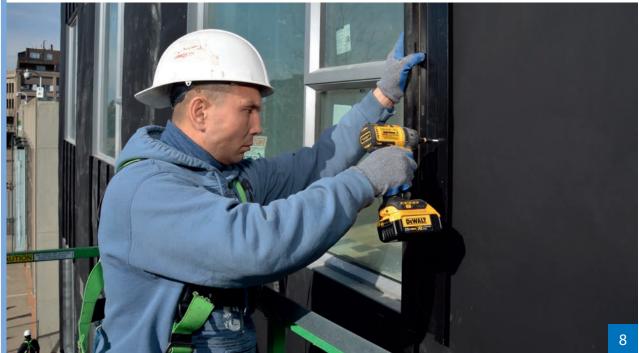
One of the unique features of this new build was the enclosure design. The exterior of the CLSB is made up of prefinished perforated panels of aluminum, engineered in a corrugated profile. While this specific feature provided the building with enhanced visual interest, one technical challenge was wind and water intrusion. It was important the design meets the project's stringent water intrusion goals. Open-joint cladding systems specifically require extreme water and wind protection.

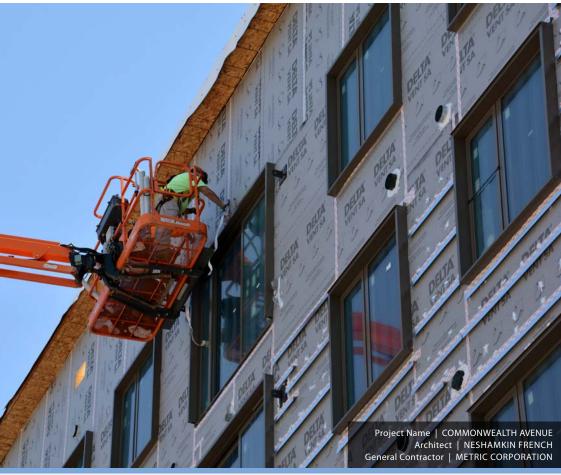
To fully observe the condition and performance of the membrane, testing was done in increments—7,000 cycles with a positive pressure differential of 575 Pa (12 psf), followed by 2,000 cycles of negative pressure differential at 575 Pa. Given that no test existed for this kind of design previously, the laboratory created a test based on ASTM E1233, *Standard Test Method for Structural Performance of Exterior Windows, Doors, Skylights, and Curtain Walls by Cyclic Air Pressure Differential*.

The results of the test showed no measurable wear, indicating the WRB was quite durable. However, given the severity of the weather

in Oregon, the team wanted to dig further. Therefore, after the initial testing, the team tried a five-minute cycle at higher wind velocity pressures, up to 193 km/h (120 mph) and performed destructive testing on the wall system. No rips or tears were seen on the membrane, but the z-girts gave out before the membrane did.

Special testing was required for the application, as the building is subject to extraordinary wind conditions. The concern was the durability of the membrane, particularly at fastening points, since it would be subject to the cyclic action of wind pressures. The testing was a collaborative effort and was critical to measure the WRB's structural strength and durability. The testing was done over the span of two days, where the lab put the membrane through 9,000 cycles of pressure differential, each consisting of three seconds of pressure followed by three seconds of rest.

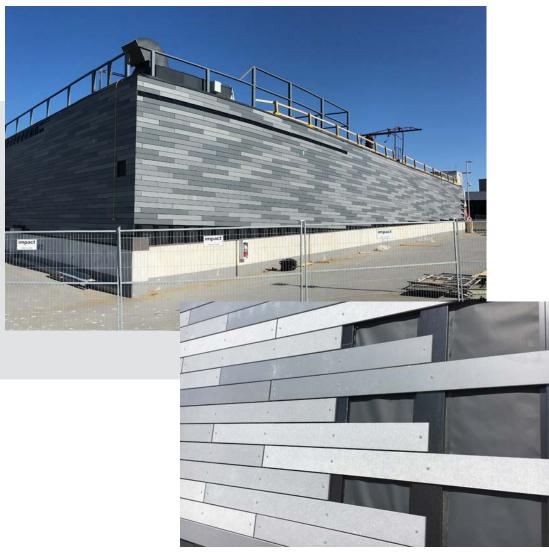
CACTUS CLUB TORONTO, CANADA

The 20,000-square-foot restaurant designed by Assembledge+ is protected by DELTA®-FASSADE S, a water-resistive barrier that acts as a durable drainage plane, channeling water from wind-driven rain and snow to the outside of the structure – performance is maximized without compromising aesthetics in open-joint cladding applications.

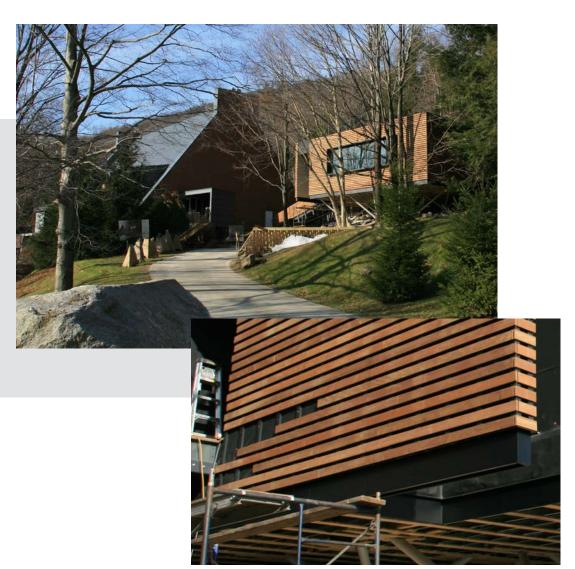
SPA BALNEA QUEBEC, CANADA

The architect's answer was a centrally located minimalist pavilion on stilts. The open-joint wood cladding and wooden walkways integrate the building into the landscape in a contemporary style. It houses the reception area of the spa as well as the offices, creating more space for the spa and treatments in the principal building.

DELTA®-FASSADE S was used by BLOUIN TARDIF Architecture – Environnement to add depth of beauty and superior performance to the building enclosure.

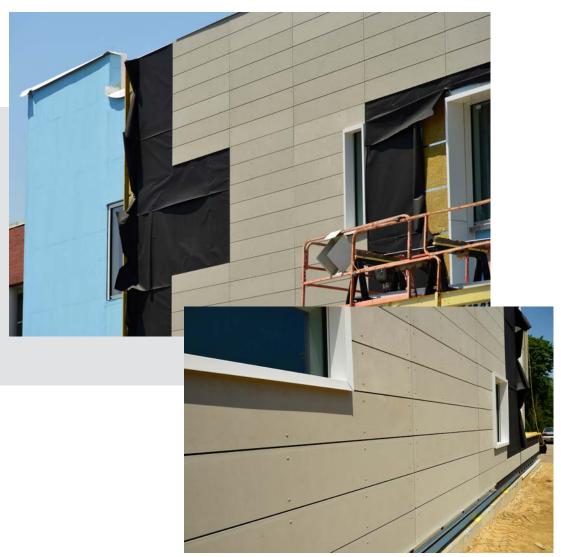
EAST MAIN BAY SHORE

TPG Architecture designed an 18,000-square-foot, two-story, Class-A office building and was retained afterwards by the tenant to design a multi-practice space out of the building's interior. Built using durable, lightly textured fiber cement, the exterior cladding is fire resistant, provides durability, and maintains a sought-after look with minimal signs of aging.

Although offering many architectural design benefits, fiber cement is not well equipped to protect a building against moisture, which is why DELTA®-FASSADE S was installed to enhance the building envelope's overall performance.
