June 2021 Vol. 63 No. 4

What is Happening Behind Stucco and Manufactured Stone?

By Peter Barrett

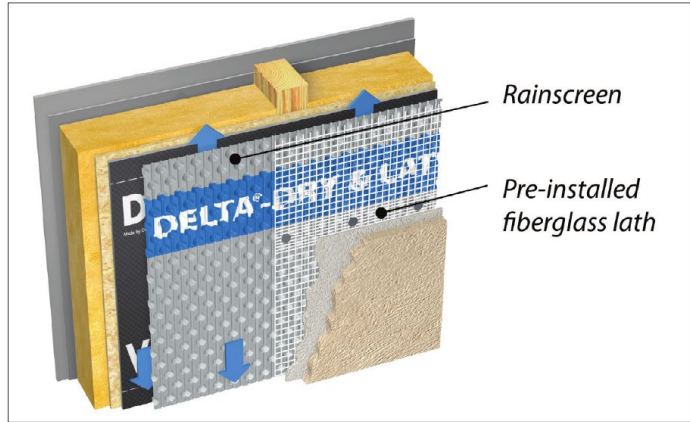
Illustration of stucco installed over a rainscreen with pre-installed fibreglass lath.

To create a high-performance wall system, a two-in-one rainscreen and lath was selected. Located in front of a spun-bonded polypropylene, self-adhering air- and water-resistive barrier, the rainscreen system features a drainage and ventilation layer in one, but also incorporates lath for the first scratch coat of the stucco. Simplifying many steps, the ventilated rainscreen with pre-installed glass lath will help to eliminate the building enclosure's risk of solar-driven moisture. At the same time, this one-step moisture control and lath system allows any incidental moisture from within the wall to dry to the outside.

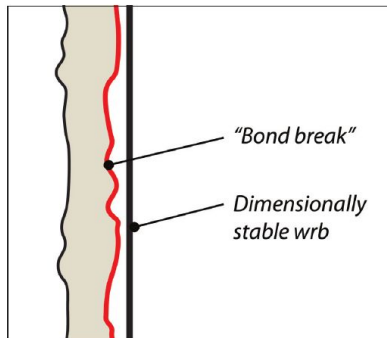
Illustration of bond break between stucco and weather-resistant barriers (WRBs).

The initial solution was to use two layers of WRB—the outer layer would act as a bond break and the inner one would be the ‘true’ dimensionally stable WRB. However, these assemblies lacked enhanced drainage and drying.

Professionals have since learned the more effective means of accomplishing both is to provide a drainage mat between the bond break and WRB. Moisture can be fully blocked by uncoupling the stucco from

the rest of the wall and installing the stucco over a vented and drained air gap.

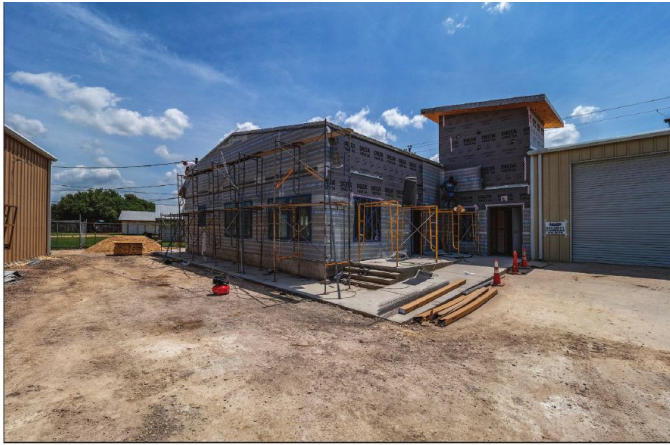
The exterior of the fire station is made up of stucco cladding. This design required a durable building envelope that could withstand the notoriously hot and humid climate in Texas with a focus on airtightness and vapour permeability.

The exterior of the fire station is made up of stucco cladding, a design element that can be resistant to fire, rot, mould, impact, and termite infestation for as long as 100 years when properly installed. The design required a durable building envelope that could withstand a notoriously hot and humid climate in Texas with a focus on airtightness and vapour permeability.

Unlike traditional methods, the fire station's exterior cladding is efficiently uncoupled from the rest of the assembly, thereby giving it longevity and durability.

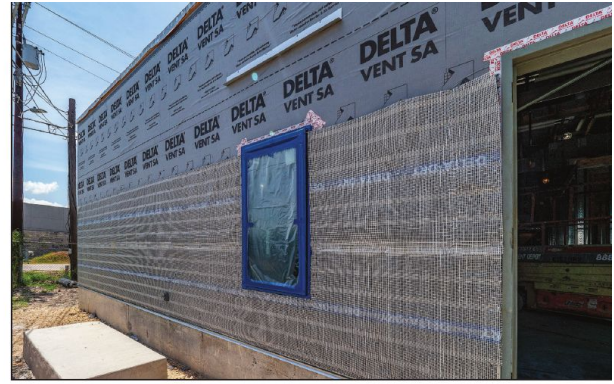
Ventilated rainscreen membrane made of a special high-density polyethylene (HDPE) with pre-installed glass lath.

a dimpled membrane, or ventilated rainscreen. By disconnecting the cladding system, it uncouples it from the rest of the assembly, thereby improving longevity and durability. Without breaking the bond between commonly used housewraps and stucco to provide an air gap, coupled with the use of an alkali cementitious base scratch coat that can act as a surfactant, stucco cladding systems will continue to fail.

There are products incorporating all these qualities. For example, ventilated rainscreen membranes made of a special high-density polyethylene (HDPE) with pre-installed glass lath are multifunctional and provide high moisture permeability along with the all-important water- and air-tightness. 🇨🇦

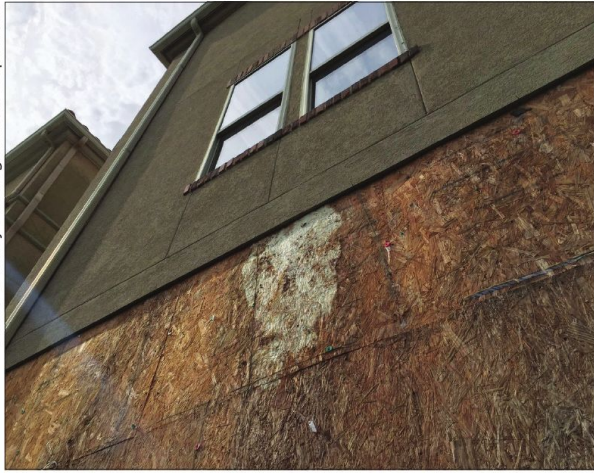
Moisture damage on wood frame low-rise building.

Vancouver in the 1990s, when stucco bonded to plastic weather-resistant barriers (WRBs) had rotted oriented strand board (OSB) behind the WRBs.² Then the issue moved south and east to places like Minneapolis, Minn., and Greensborough, S.C. First, it was noticed on multistorey, wood-frame buildings because rain exposure increases with height, and then on regular wood-frame low-rises.

Trapped moisture can cause severe issues that may not be evident until it is too late. For example, the commonly known ‘stucco

tear’ stains that appear under installations such as windows are signs of moisture-induced damage to the wall systems. Other warning signs include:

- dark spots;
- heavy staining;
- odour;
- cracks;
- bulges in the stucco finishes; and
- missing stucco.
